Geological analysis of the Kållered quarry and surrounds Sand & Grus AB Jehander

20 December 2013

Assignment ref.: 10187955	Geological analysis of the Kållered quarry and surrounds	
Dated: 20 December 2013	Report	WSP
Revised:		
Representative: Paul Evins	Status: Final

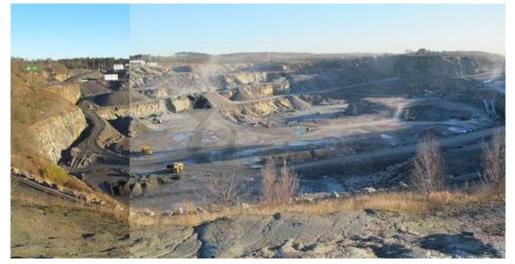
Fig. 2. View towards SE of the central part of the Kållered quarry.

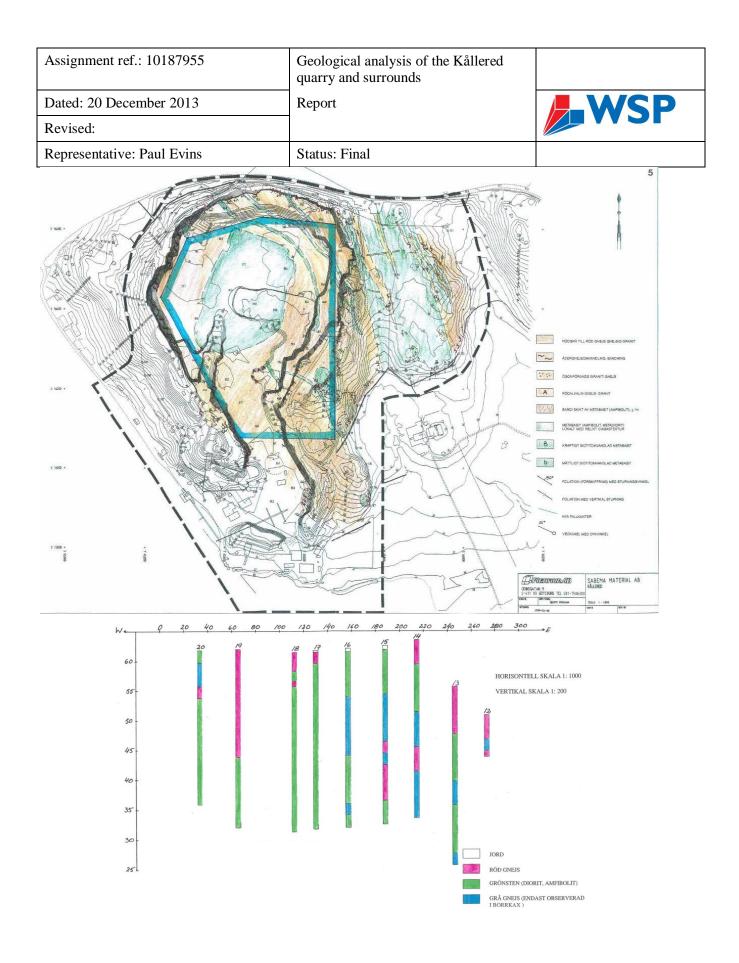
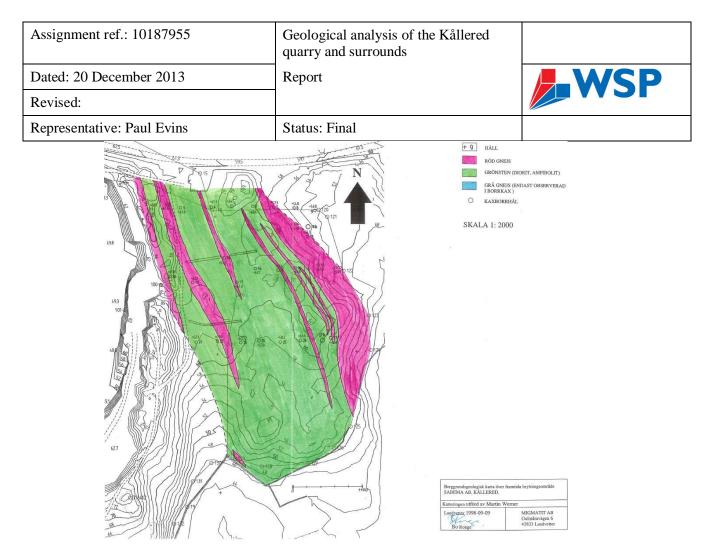
Fig. 3. Top - Previous geological map of the Kållered quarry and surrounds (Hersvik 1999). Centre – example rock chip logs from area east of the quarry (Ronge 1998). Bottom – map of area east of the quarry (Ronge 1998).

Both studies included ocular geological mapping of surfaces inside and outside the quarry. The map of the area east of the quarry (Ronge 1998) incorporates data from two c. 200 m long trenches and 27 RC drill holes each roughly 30 m long. (Fig. 3).

The locations of rock boundaries in plan view on the previous maps are generally correct (Fig. 3). However, the shape of the gabbro body has been revised, mainly due to new information available due to further excavation in the quarry. In particular, the bottom of the gabbro layer was observed along the western wall of the lowest quarry level. Additionally, some of rock boundaries in the eastern part of the area have been adjusted due to new observations. Our mapping has revealed that some of the important rock boundaries are controlled by ductile (folds and shear zones) and brittle (faults) structures. A N-S fault zone runs through the central part of the quarry and divides the geology into eastern and western parts. The rocks in the western part of the quarry are folded by multiple generations making the shapes and contacts of rock units complex (Fig. 11). This makes the rock contacts very difficult to visualize in a 2D-map due to their complexity and moderate dip. The bottom of the gabbro unit is seen at the bottom of the quarry and is interpreted to be a c. 60 m thick sheet within the gneissic layering that dips shallowly to moderately to the west. There is a possibility that it is bowl shaped or repeated by folding which may account for its recurrence further to the west. The rocks in the eastern part of the quarry consist of a c. 50-150 m thick, moderately westward dipping amphibolite with 10 to 20 m thick sheets of red-grey intermediate gneiss.

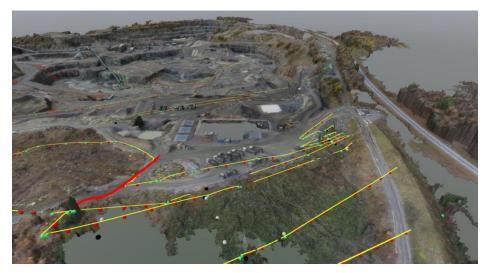
Fig. 4. Screenshot from the VR model used during compilation of the geological map. The black and white spheres in the foreground represent DGPS measurements of rock occurrences (black: amphibolite, white: redgrey gneiss). Yellow lines are interpreted rock contacts and red lines: fauts. View towards NW.

The previous maps presented above were georeferenced into a VR workspace which contained the 3D orthophoto model provided by Johan Lindqvist of Rotoview. This VR workspace is a standalone application that allows Sand & Grus AB Jehander to view Rotoview's 3D model on a normal PC without extra software. The maps are hand drawn copies and very few reference points could be used to place them into correct geographic space. Therefore, there may be local errors between like points on the maps and orthophoto. The site was first visited by project manager, Paul Evins and geologist Björn Sandström on 12/11/13 to establish mapping protocols and understand the large scale geological structures in the area. The bulk of field mapping was carried out by Björn Sandström during the period 21/11/2013 - 26/11/2013. Observations were made using standard field equipment and techniques outlined in Coe (2010). Field mapping was based on the VR-model, field observations were hand drawn on printouts from the VR model, then digitized into the VR model (Fig. 4), and then exported to CAD (Fig. 5). Observation locations in the undeveloped eastern area outside the quarry were measured with DGPS with 5 cm accuracy. All field structural measurements were taken with a Silva compass with levelling bubble and clinometer. All field structural measurements are reported as strike-dip according to the right hand rule and are not adjusted for magnetic declination. Data from the previous maps from the quarry (Ronge 1998 and Hersvik 1999) were also incorporated into the map, especially where outcrops have been blasted away.

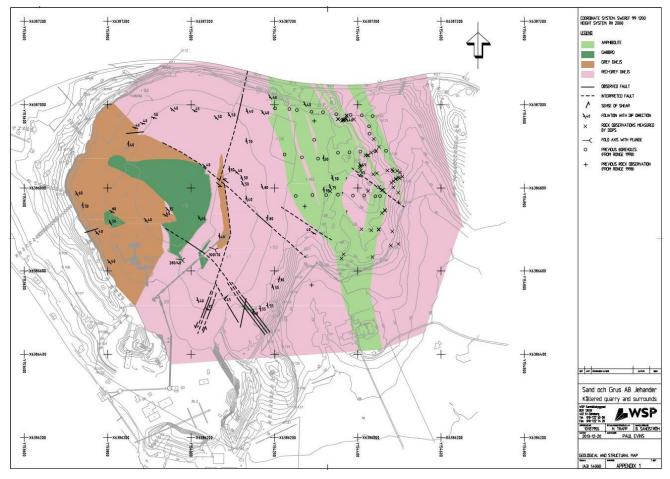
Fig. 5. New geological map of the Kållered quarry and surrounds. The full map is presented in Appendix 1 and electronically in Appendix 2.

In the eastern part of the investigated area, abrupt changes in the thickness of red-grey gneiss and amphibolite units imply the presence of NW-trending faults (Fig. 5). Some of these structures were observed on quarry walls, but the ones responsible for the thickness changes have not been observed in the field and need to be confirmed by drilling or trenching.

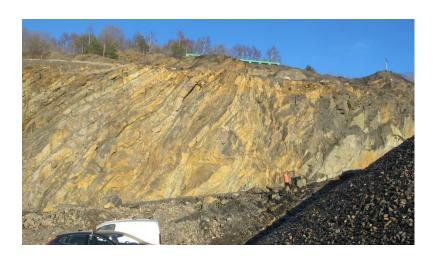
Fig. 8. Red-grey granitic gneiss. Left - meter-scale banded. The base of the left photo is ca three meters. Right – cm scale banded and tightly folded augen gneiss layer

A medium grained, red-grey granitic gneiss dominates the central parts of the investigated area (Fig. 8). The gneiss is tectonically banded and locally highly folded. In the central and eastern part of the quarry, the bands are

dm-m scaled. In the western part of the quarry and in faults, it is cm-scale banded. There are four rocktypes that make up the bands in this gneiss. The oldest is the grey intermediate gneiss described above. Locally there are layers of augen gneiss which represent originally sheets of porphyritic granite with up to cm-scale K-feldspar phenocrysts. Together these were intruded by various generations of pink granite and black mafic dykes which have been transposed into the layering. Along some of the fracture zones, particularly the water conductive zones, the gneiss is altered and rust-colored due to precipitation of Fe-oxyhydroxides.

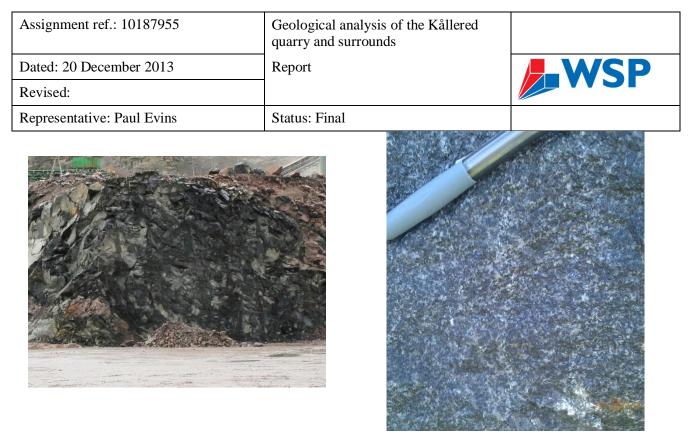
Fig. 9. Gabbro occurrence in the central part of the quarry.

The gabbro that occurs in the central-western part of the quarry is fine- to medium-grained and dark grey. It is equigranular (Fig. 9) to weakly lineated. In the contact zone close to the red-grey and grey gneisses, backveining and some mixing between the different rock types can be seen. The lower contact of the gabbro has been uncovered along the western wall of the lowest excavation level in the quarry. The gabbro is relatively fresh with little later alteration. Normal retrograde metamorphism occurs locally amphiboles retrograded to biotite and biotite to chlorite. Minor occurrences of sulfide are associated with quartz veins in the gabbro near its contacts.

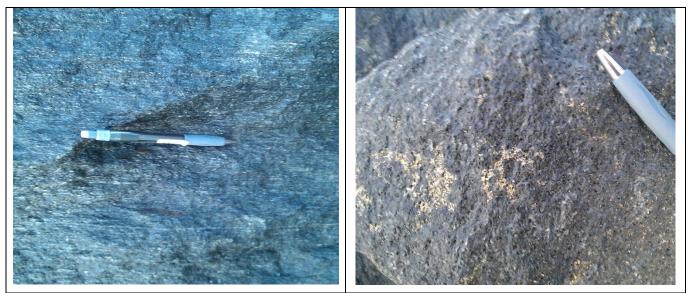
Fig. 10. Biotite rick amphibolite with distinct foliation (left) and together with sulfides (right).

Amphibolite occurs abundantly in the eastern part quarry. The amphibolite is biotite-rich and shows a distinct foliation following the general foliation pattern of the gneisses in the area (Fig. 10). Locally, minor sulfide mineralization occurs within the amphibolite. It is unclear if the amphibolite is an altered, weathered, more deformed version of the gabbro described above. However, its response to deformation (foliation in the amphibolite vs. lineation in the gabbro) suggest it is not the same rock unit. A couple of geochemical analyses from both rock types could test this hypothesis.

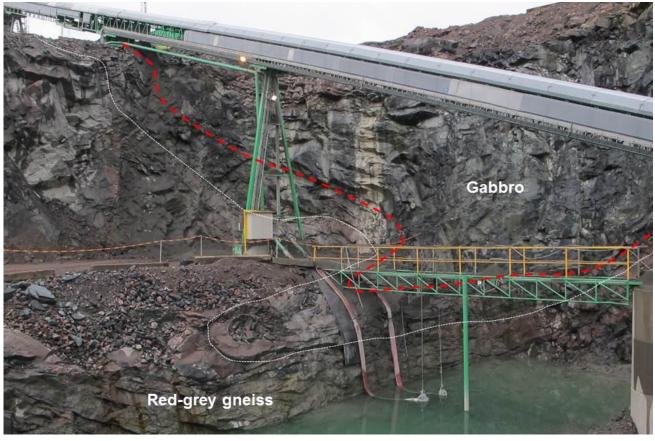
Fig. 11. Isoclinal fold (white line) and complex rock boundaries (red line) between gabbro, red-grey gneiss and grey gneiss.

Meter-scale to 10 meter-scale folds were observed in the eastern contact zone between the gabbro and the redgray gneiss (Figs. 11 and 15). Two moderately west plunging $(300/70^{\circ} \text{ and } 280/40^{\circ})$ fold axis were identified and measured and are presented on the map in Appendix 1. The plunge of this folding generally matches the plunge of macroscopic scale warping $(280/40^{\circ})$ of foliation which is best seen where the NNW striking foliation arcs counterclockwise into near parallelism with the northern quarry wall (Figs. 5 and 16). The folding on this scale is complex and the 3D-extent of the rock types controlled by this folding cannot be fully understood without construction of a 3D model.

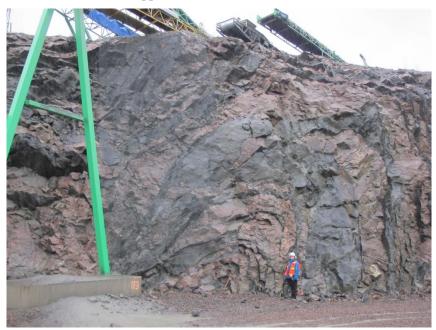
Fig. 15. Folded gabbro and red-grey gneiss in the central part of the quarry, the plunge of the fold axis is 280/40°.

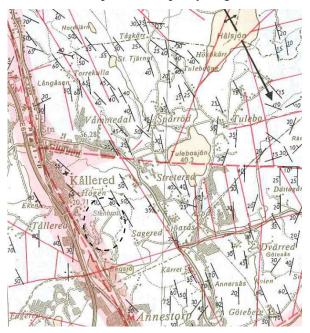
Fig. 17. Tectonic map of the area around the Kållered quarry (marked with circle). The pink field the represents the Göta Älv shear zone. Red lines represent fracture zones (map from SGU 1987). The base of the map is c. 4,5 km.

The gneissic layering in the quarry generally follows a pattern of regional kilometer-scale folding. The quarry is situated on the western limb of an NNW striking anticline with a wavelength of 4-5 km (Fig. 17). Gneissic layering (foliation) in the quarry strikes NNW-SSE and dips moderately (35 to 70°) westward (Appendix 1 and Fig. 8 and Fig. 16). The foliation is undulating and openly folded. In the central parts of the quarry, the foliation is folded into the N-S fault zone. In other areas the foliation changes abruptly across NW trending faults indicating some degree of block rotation (Appendix 1).

The western part of the quarry is situated within the Göta Älv shear zone, a regional NNW trending fault zone (Fig. 17). The zone has both a ductile and brittle history. The main gneissic layering is oriented parallel to this zone reflecting ductile transposition of layering parallel to the zone. The most prominent brittle structure in the quarry is a fault zone seen in the northern wall (Fig. 18). This zone can be traced towards the south across the quarry and to the southern wall where it appears as several more discrete faults spread over a larger area (see map in Fig. 5 and Appendix 1). Movement along this N-S trending fault is responsible for juxtaposing the different rock types found in the western and the eastern part of the quarry (Fig. 19).

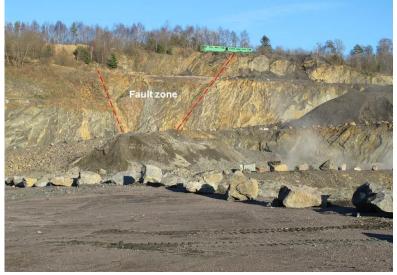
Fig. 18. N-S trending fault zone in the northern wall of the quarry.

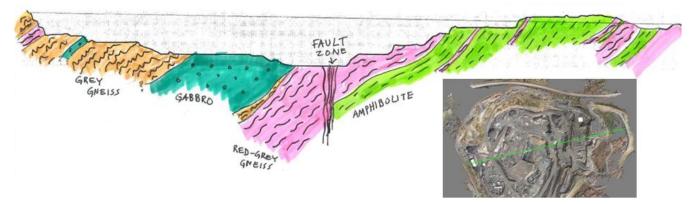
Fig. 19. Schematic WNW-ONO section across the N-S fault zone. For location of the section, see inset figure. Observe that all rock occurrences not are included in the section.

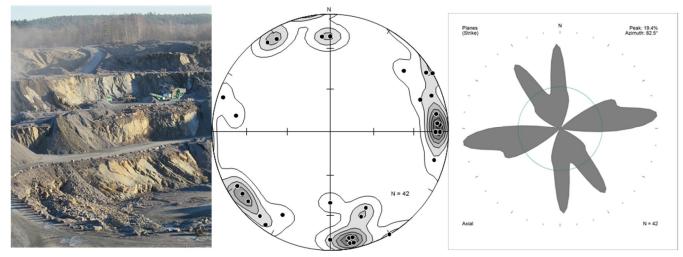
Fig. 20. Left - View towards the SE of unfavorably oriented foliation planes on the eastern wall causing unstable slopes. Centre - Lower hemisphere stereographic projection of poles to joints (dots) in the Kållered quarry and surrounds. Foliation joint planes not included. Right – rose histogram of the strike of joints in plan view.

The main foliation planes (Fig. 16) form moderately westward dipping sheets which are a major problem for bench and slope stability along the eastern side of the quarry (Fig. 20 left). Apart from the main foliation planes, there are 3 joint sets present in the quarry: N-S, NW, and E-W trending (Figs. 20 centre and right). All are nearly

vertical. The N-S joints are related to the N-S trending faults described in 6.3.2. The NW trending joints are related to the NW-trending faults described in 6.3.3.

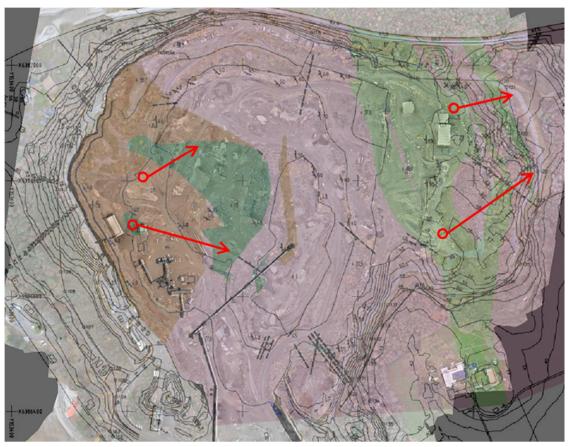
Fig. 18. Suggested location and direction of core drilling (red arrows).

We recommend core drilling to obtain structural and rock type data from depth and test the above interpretations. In particular, they drill cores may be used to constrain the thickness of the gabbro and amphibolite. Two boreholes (100 and 250 m long) with a low angle (c. 45°) towards the east should be drilled through the amphibolite in the eastern part of the quarry. One of the holes should be orientated so that it penetrates the inferred fault zone in the area. Furthermore, two boreholes (100 m and 200 m long) should be drilled in the central-western part of the quarry with the aim of determining the extent and shape of the gabbro body (Fig. 21).
